LAKE MONTEBELLO

NDI ID NO. MD-107

PHASE I INSPECTION REPORT
NATIONAL DAM INSPECTION PROGRAM

JUNE 1980

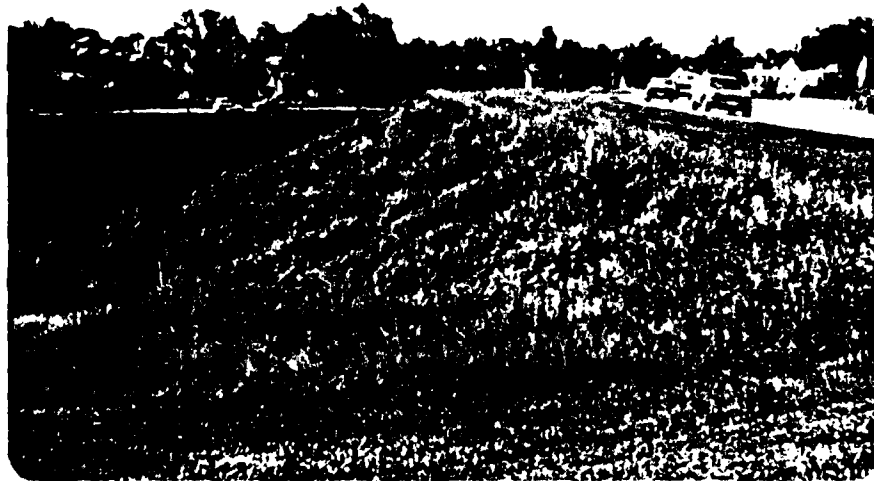
A. Crest and North Side of
Eastern Embankment

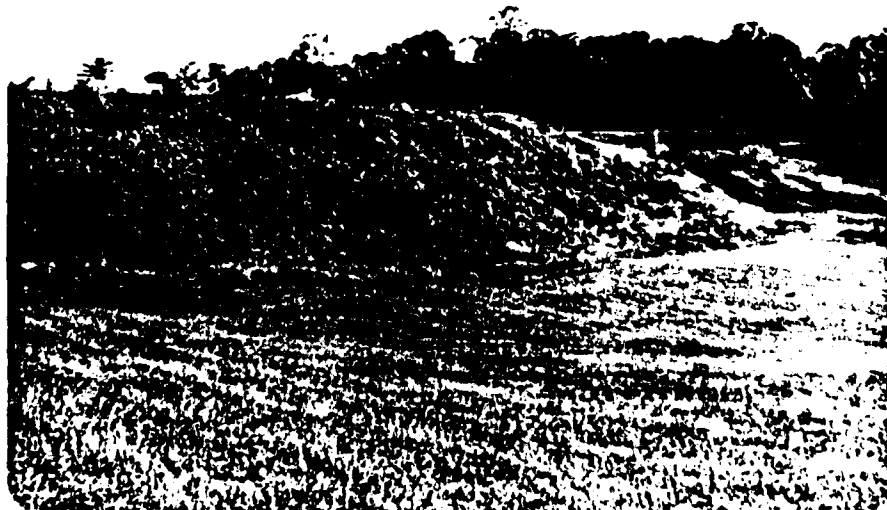
D. Downstream Embankment -
Northern Half

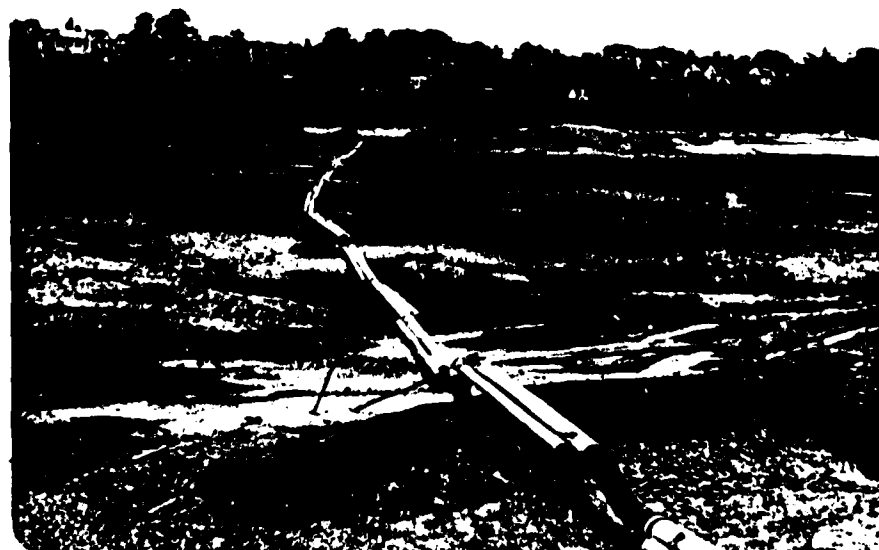
F. 10 Inch Diameter Pipe from
Wash Water Lake.

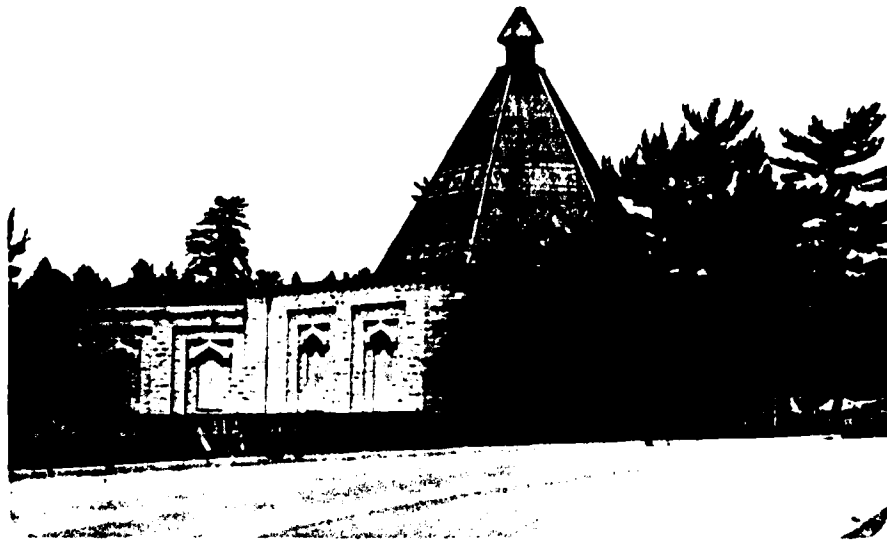
G. Lake Montebello Gate House

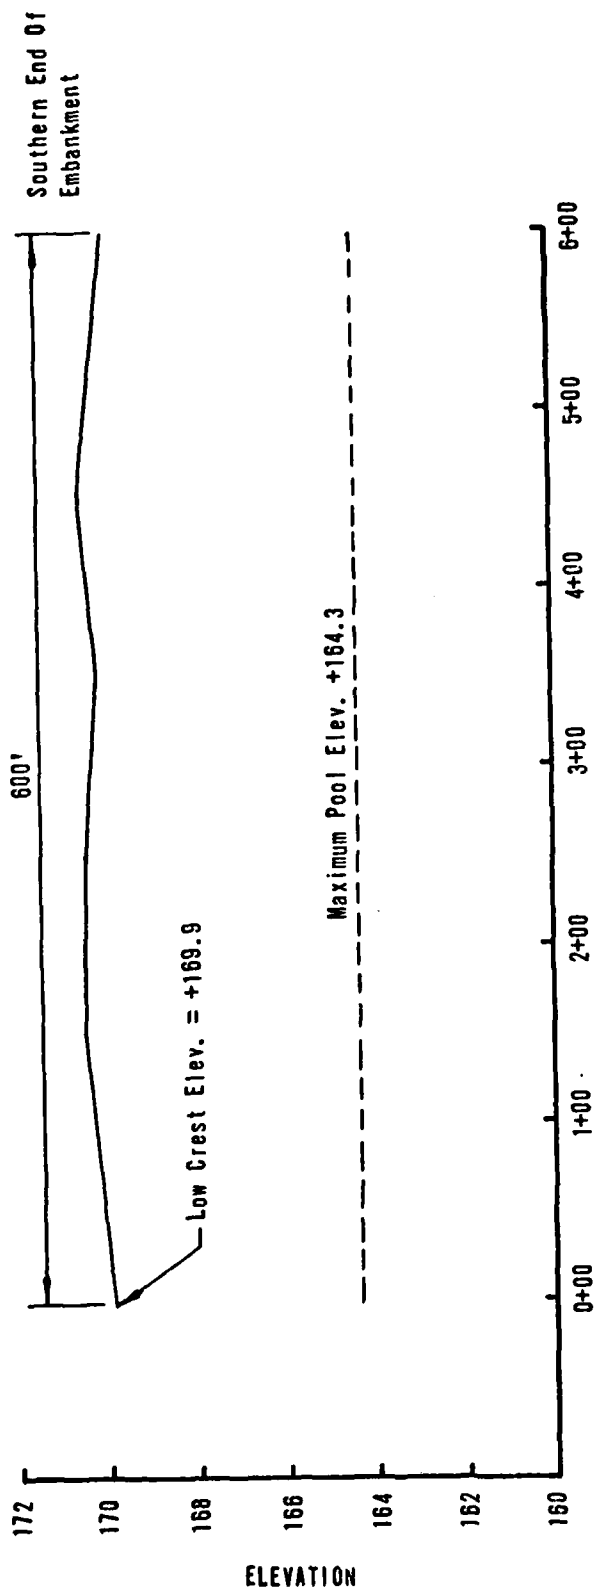
DAM CREST PROFILE
(LOOKING DOWNSTREAM)

The crest of the dam was surveyed and was found to vary in elevation by approximately 6 inches. Freeboard at the time of the inspection was approximately 25 feet (lowered lake level), and under maximum pool conditions would be approximately 6 feet. The dam crest profile is included as Plate E-4.
